Rail Accident Investigation Branch

# Rail Accident Report

## **Derailed at Grayrigg 23 February 2007**

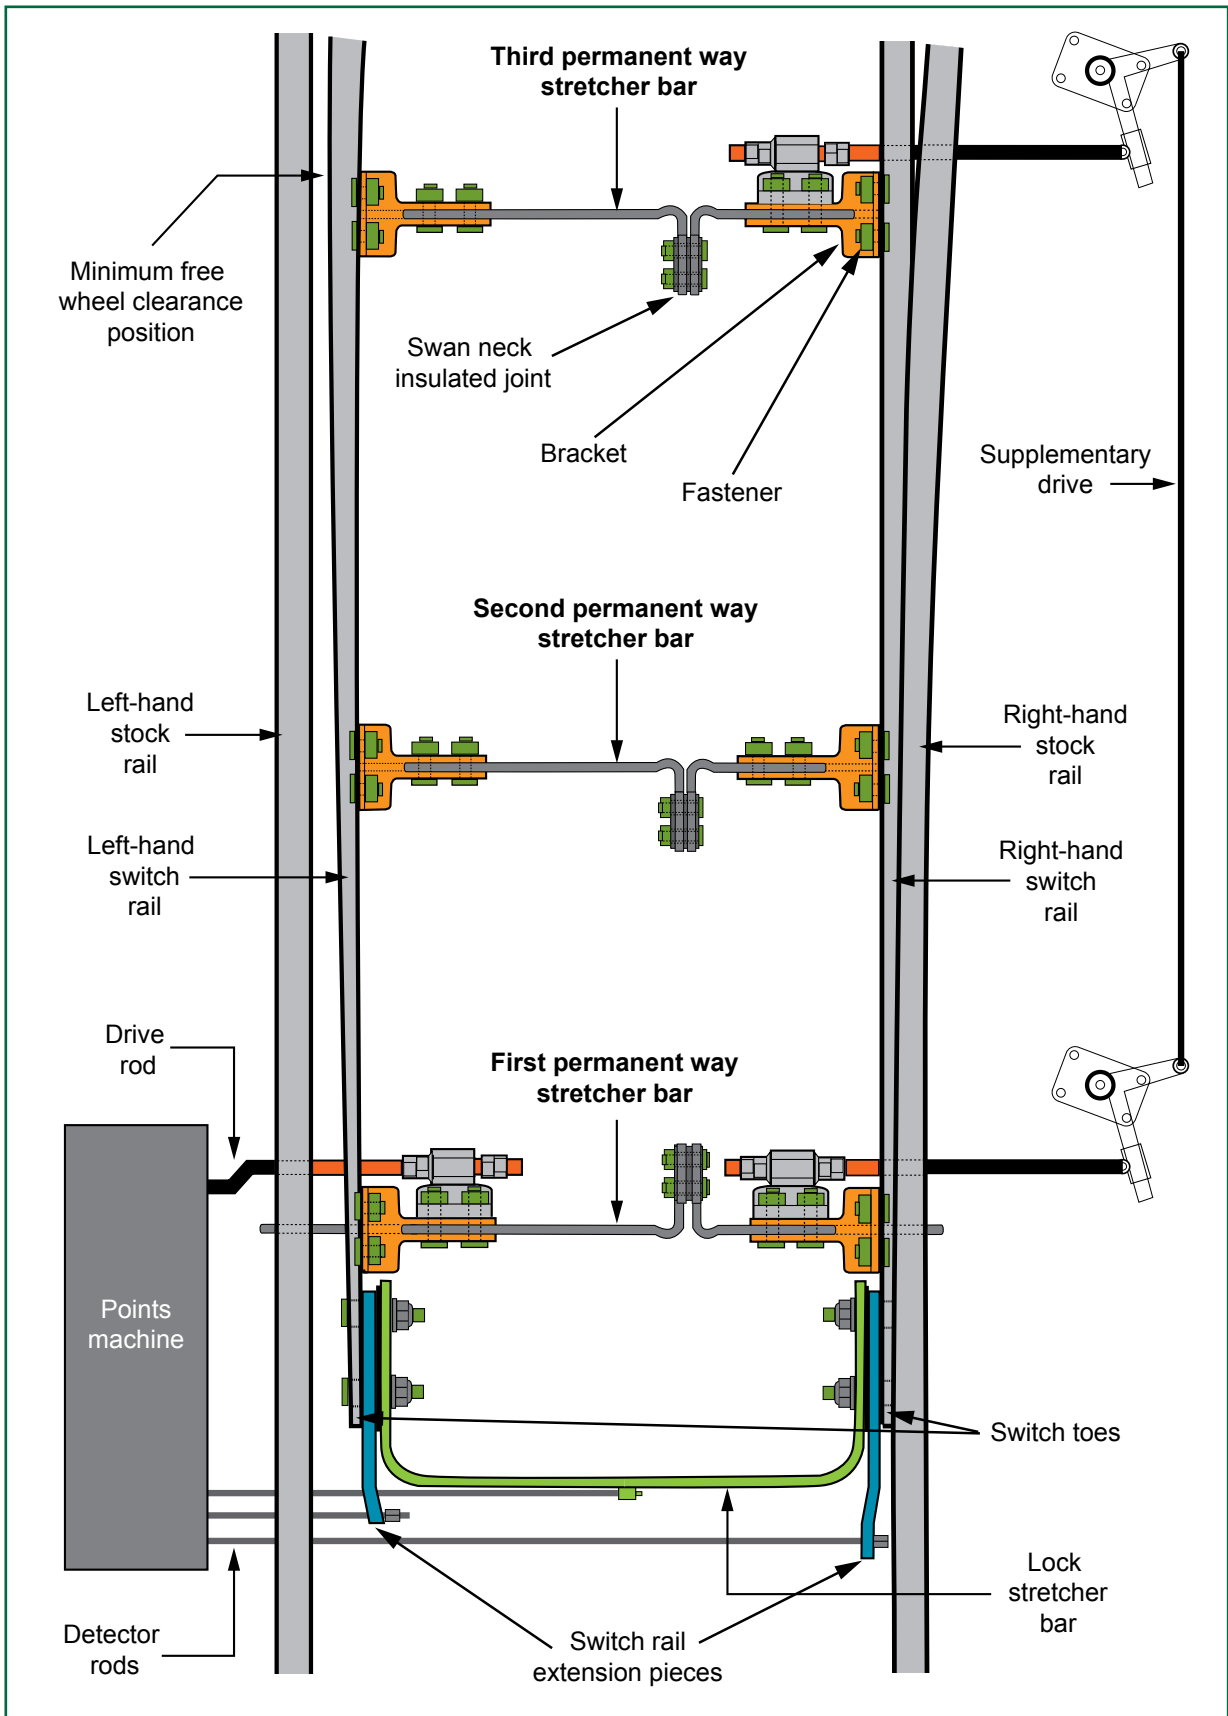
Figure 3: Layout of points showing switch and stock rails and stretcher bars

- 13 The train derailed as it passed over 2B points which were in an unsafe state. A combination of failures of *stretcher bars* and their joint to the *switch rails* allowed the left-hand switch rail to move, under its natural flexure, towards the left-hand *stock rail*. The left-hand wheels of either the first or second *bogie* on the leading vehicle (it is not clear which) passed the wrong side of the left-hand switch rail and were forced into the reducing width between the switch rails. The wheels then derailed by climbing over the rails. All the other vehicles of the train derailed as a consequence. Figures 3 and 4 show the key details of the points.

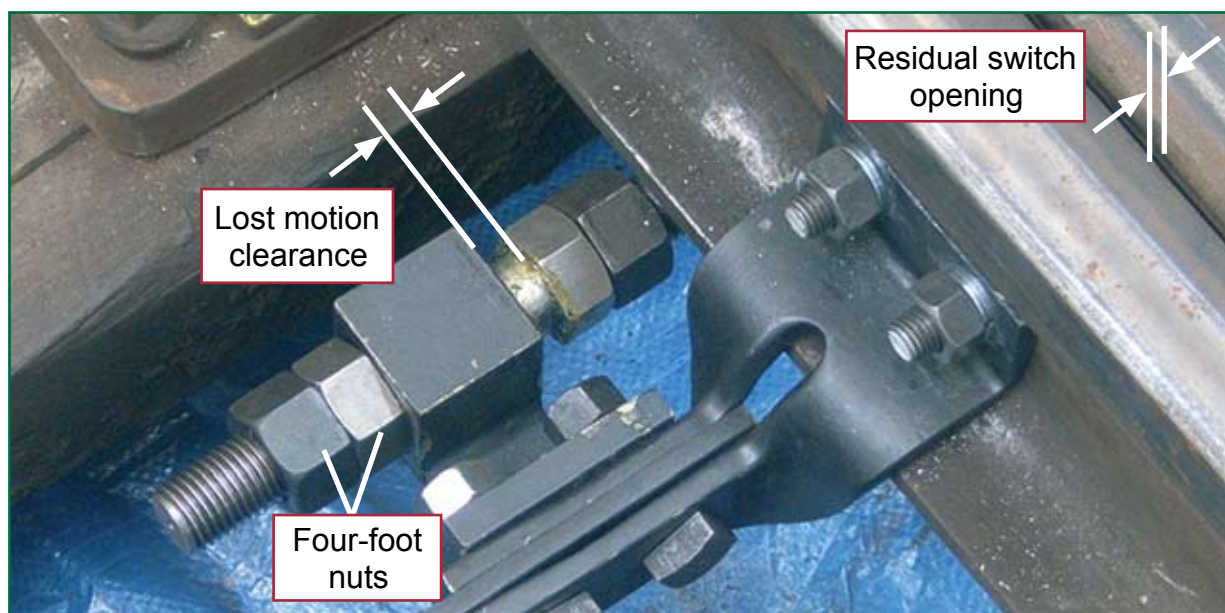
Figure 26: Escapement joint on a reconstructed stretcher bar

- 132 The supplementary drive is shown in Figure 26 and its role is described in Appendix D. The supplementary drive was complete and undamaged and all of its components were operating correctly.
- 133 Where the supplementary drive connects to the stretcher bar there is an *escapement joint*. Clearances within this joint, known as lost motion, isolate the supplementary drive and the toes of the switches from forces induced by the passage of trains. There was 16 mm of lost motion at the escapement joint at the third permanent way stretcher bar. Although this is above the maximum specified values<sup>2</sup>, the amount of lost motion itself was not significant to the accident as it provided the necessary isolation of forces.
- 134 The position of the escapement joint's four-foot nuts was such that it allowed a residual switch opening of 8 mm between the right-hand switch and stock rails.

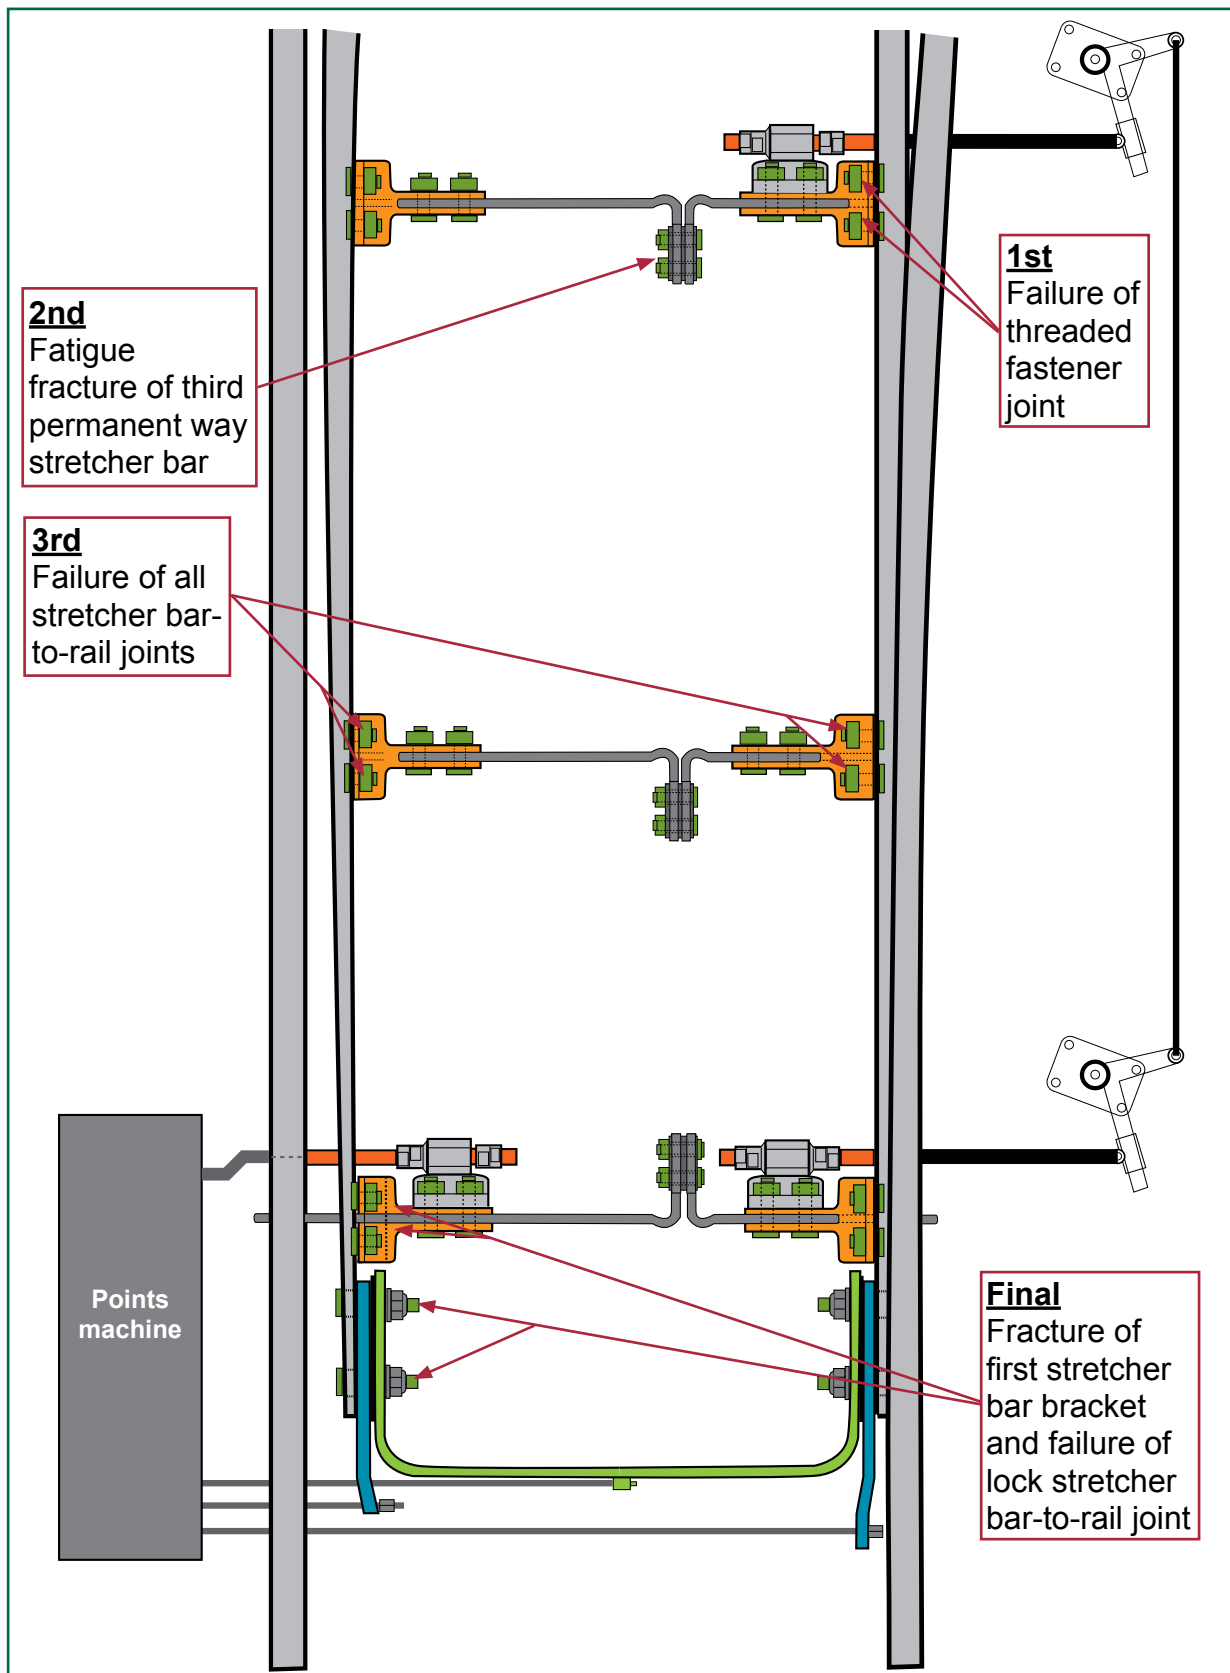
Figure 27: The sequence of failures - schematic diagram of points

135 This section describes the probable sequence of failures within 2B points, as summarised in Figure 27, and their possible causes.

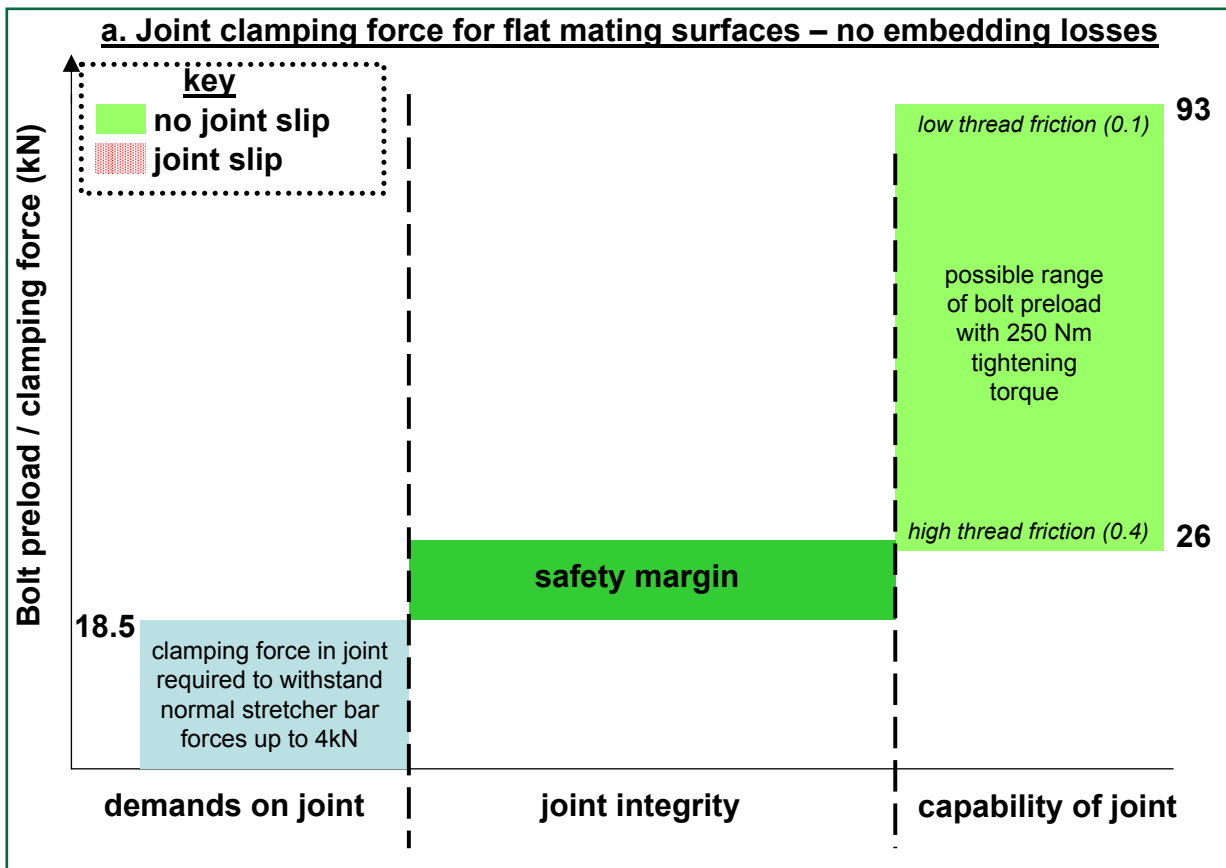
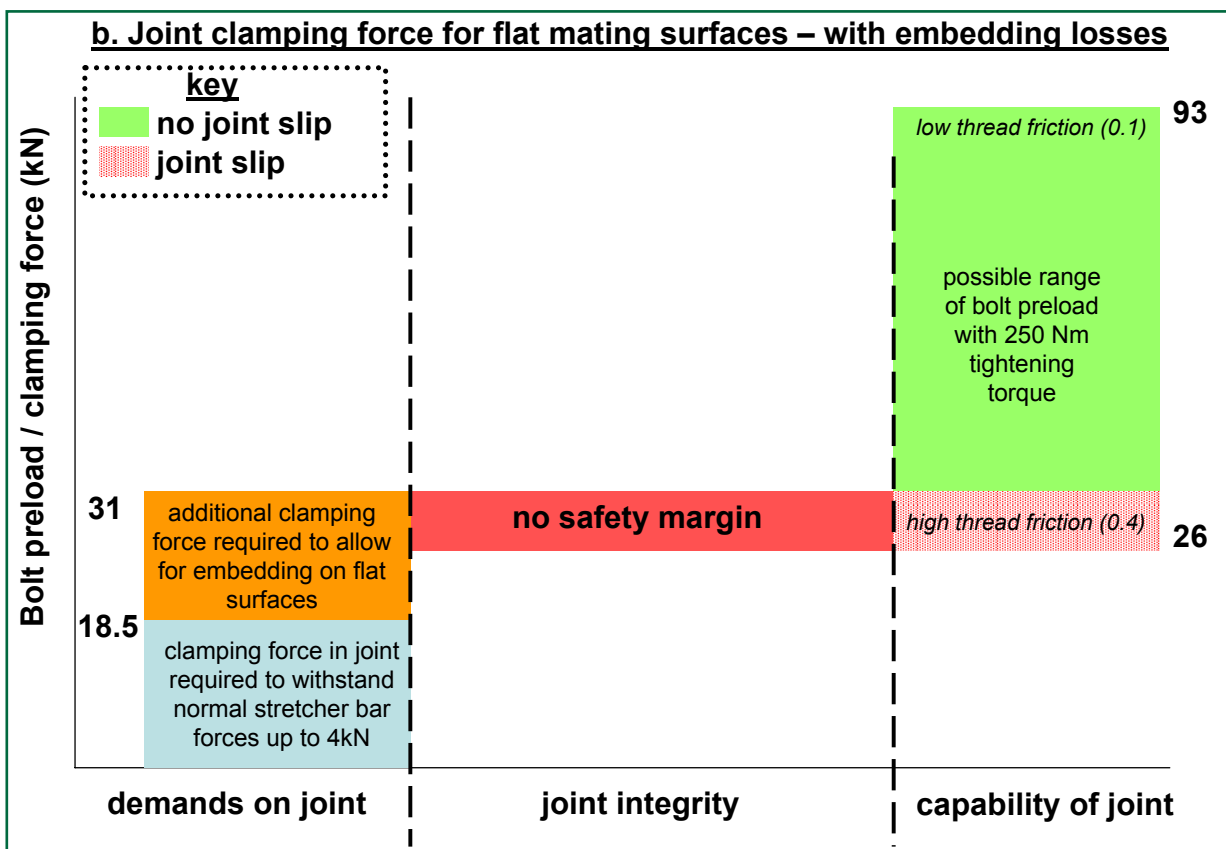
Figures 28a and 28b: The relationship between clamping force required to withstand realistic service loads and the clamping force achieved

- 148 Calculations demonstrate that this amount of embedding results in a loss of preload in each fastener of 12.5 kN. Thus to ensure sufficient clamping force to prevent joint slip, the preload in each fastener must exceed the sum of this value and the 18.5 kN referred to in paragraph 144, ie 31 kN (Figures 28a and b). No attempt has been made to predict the loss of preload due to other plastic deformation, and therefore this calculation indicates the minimum preload requirement.

- 149 The range of preloads achievable by the fastener was calculated to be between 26 kN and 93 kN. This was based on the 250 Nm tightening torque and a realistic range of friction (Appendix E). The relationship between the 31 kN minimum clamping force required to resist slip and the range of achievable clamping forces is shown in Figure 28b. This shows that for points of a similar configuration and traffic loading as 2B points, even if fully tightened, a safety margin cannot be guaranteed between the as-designed joint's clamping force and the forces it can experience in normal service, ie without any flange-back contact.

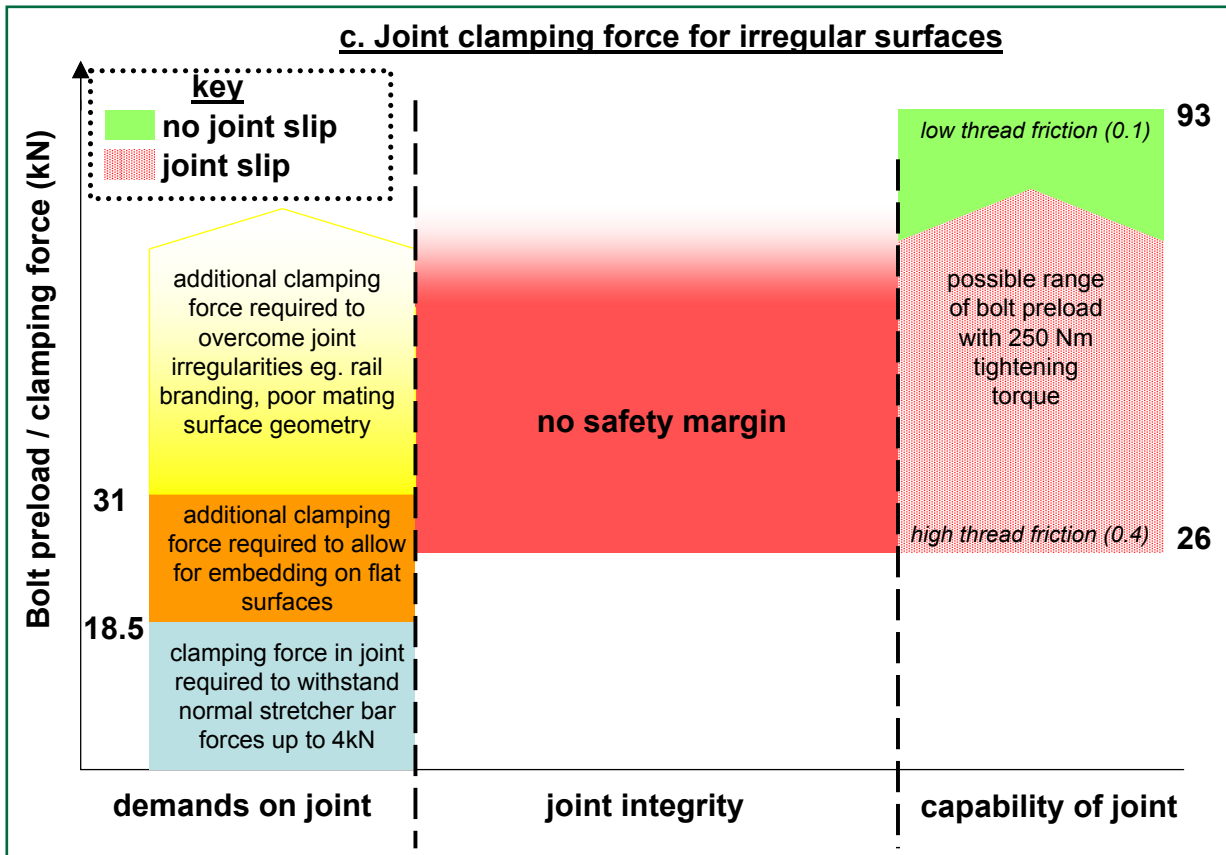
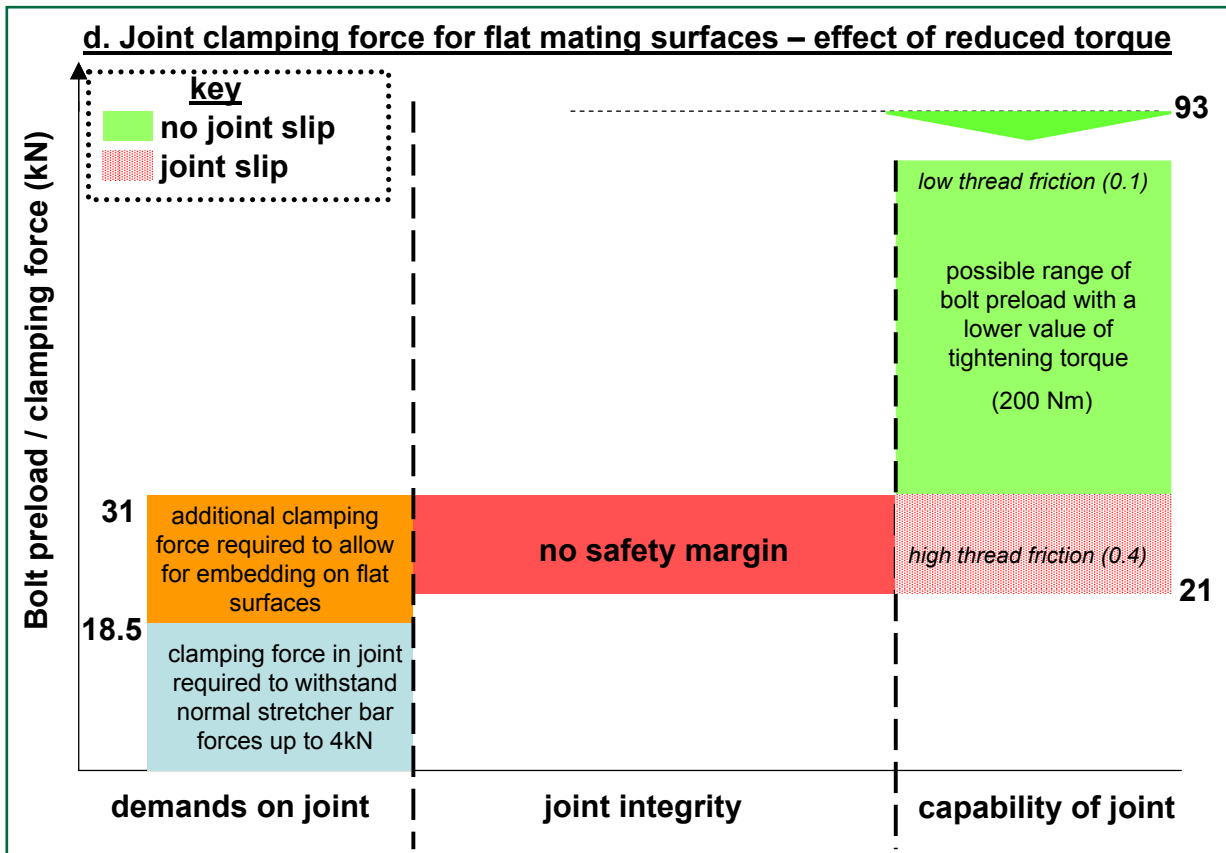
Figures 28c and 28d: The relationship between clamping force required to withstand realistic service loads and the clamping force achieved

- 150 This analysis is based on the nominal design, ie, flat mating surfaces, and the specified torque of 250 Nm. Other factors that may lead to plastic deformation of the surfaces and reduce the clamping force still further over time are described below (Figure 28c):

- 153 Tests undertaken by the RAIB on similar fasteners on other points found fastener torques as low as 20 Nm. The low torque indicated that there were significant reductions in the clamping forces in these joints, and an associated reduction in their resistance to slip failure (Figure 28d).

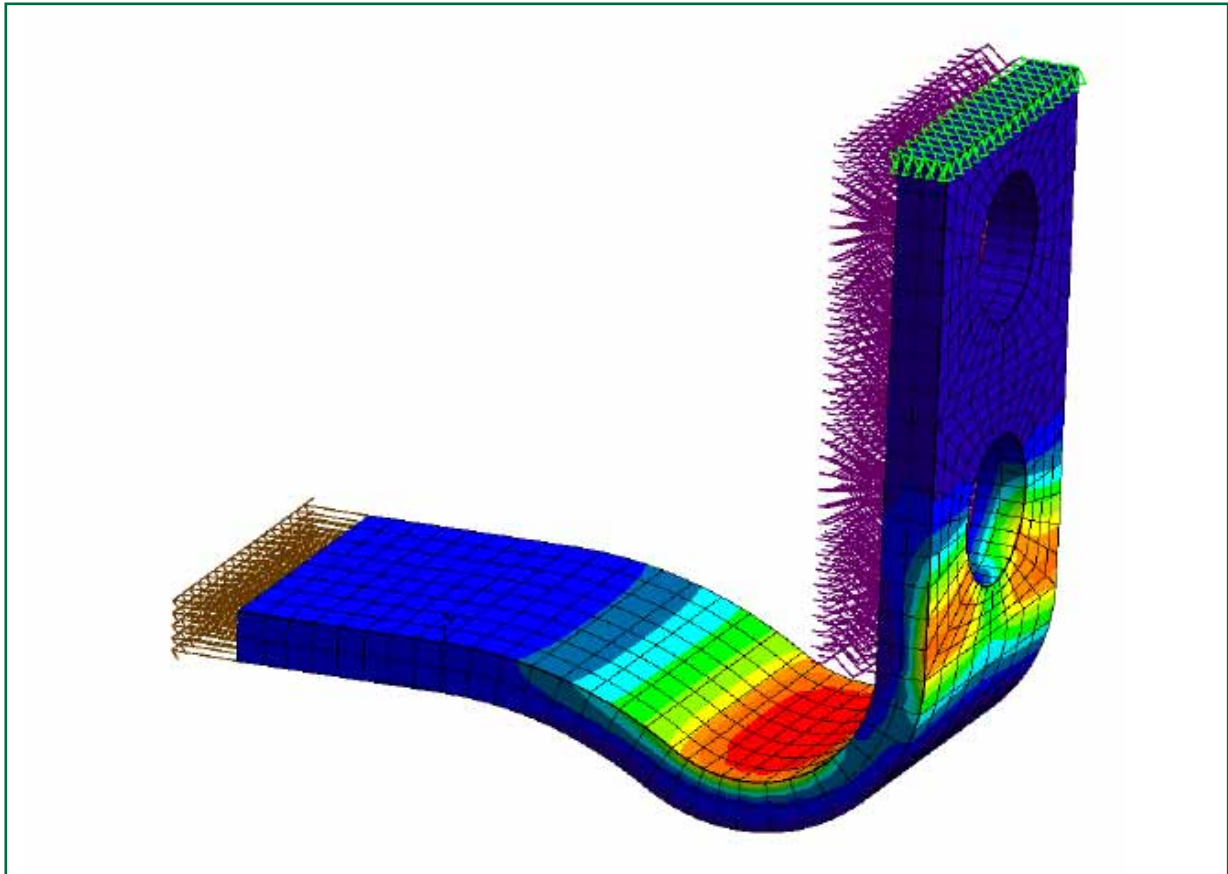
Figure 30: Stress contour plot of swan neck assembly

- 169 All of the cracks within the swan neck assembly were found to be growing outwards from the bolt holes. Therefore these cracks cannot be detected by visual inspection until the section has fully fractured.

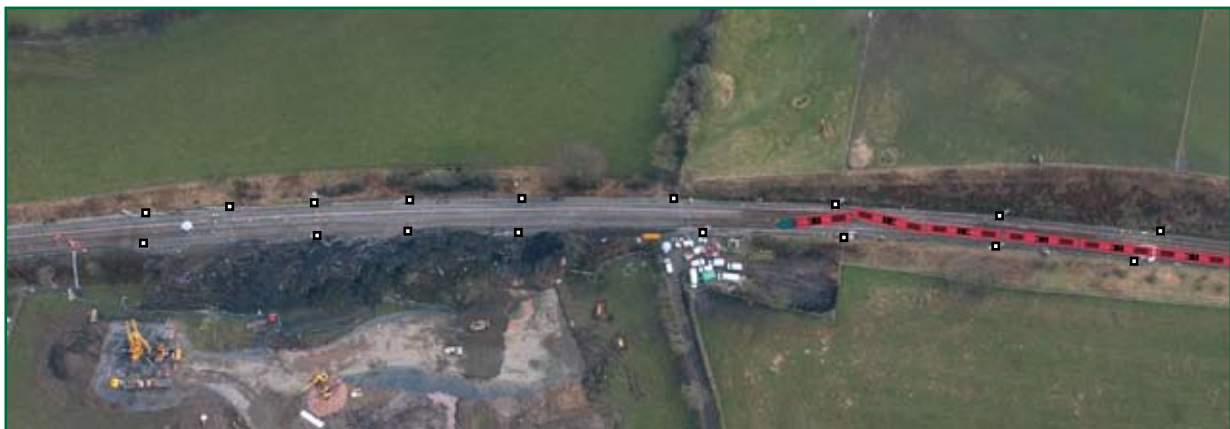
Figure 33: Diagram of the misalignment which developed between vehicles one, two and three after passing 2B points

540 Track damage showed that a number of wheelsets had crossed over and run close to, or in, the up line. These included wheels from bogie 2 and bogie 3. Whether or not bogie 1 derailed first, it stayed close to the down line and with bogies 2 and 3 running close to the up line, a misalignment formed between vehicles one, two and three, as shown in Figure 33.

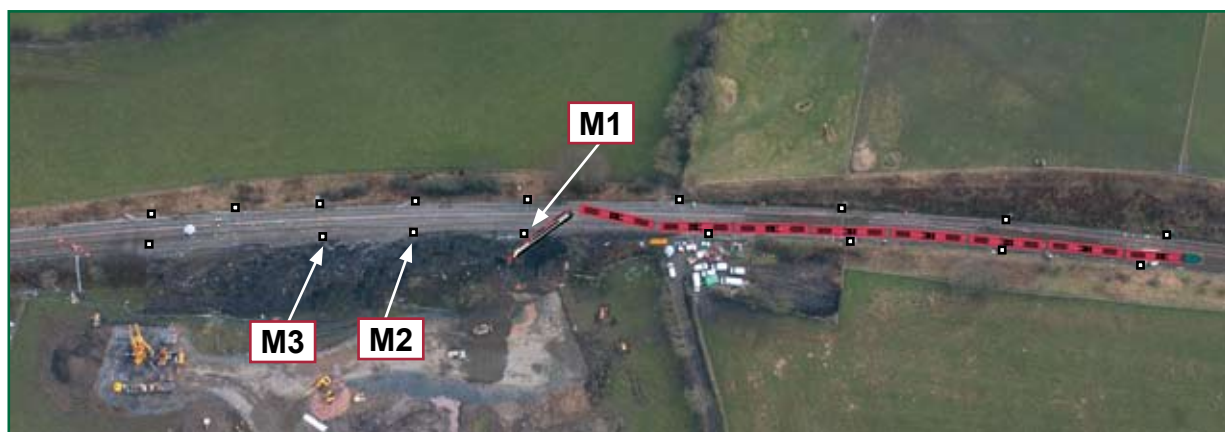
Figure 34: Diagram of vehicle one, partially rolled over and striking overhead line equipment mast M1

- 544 Vehicle one continued to yaw in an anticlockwise sense as it was pushed by the remainder of the train. When it was approximately perpendicular to the track and rolled over about 70 degrees onto its right-hand side, its trailing end struck mast M2 (Figure 34). More pushing from the vehicles behind it caused vehicle one to yaw even further until it lost contact with vehicle two and began to slide down the embankment slope. As it descended the embankment, it rolled over onto its side and continued to yaw. It came to rest at the foot of the slope, approximately 9 – 10 seconds after it first derailed, and having rotated through approximately 190 degrees to face backwards.

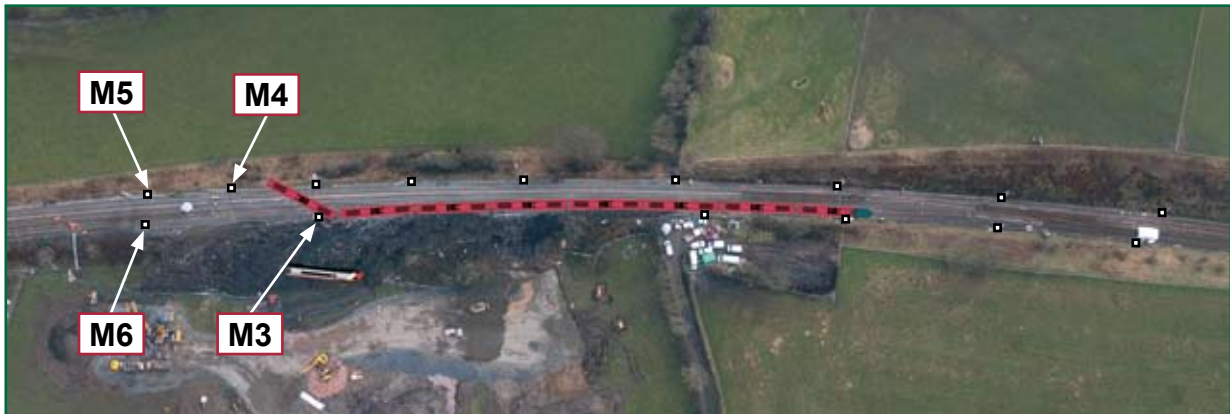
Figure 35: Reconstruction of vehicle two first striking overhead line equipment mast M3

545 Vehicle two, after becoming detached from the leading vehicle, continued to run misaligned and was pushed into yawing in a clockwise sense by the following vehicles. The trailing end of vehicle two struck overhead line equipment mast M3 as shown in Figure 35. Thereafter, it began to roll on to its left-hand side as the overturning forces resulting from the drag on its bogies increased. Its leading end then struck two overhead line equipment masts on the up line (M4 and M5 in Figure 35) and its centre section struck mast M6 on the down line. As it approached an orientation approximately perpendicular to the track, it was skidding on its left-hand side, perched on the crest of the embankment by the down line. Vehicle two came to rest shortly after with its trailing end at the foot of the embankment and its leading end overhanging the up line.

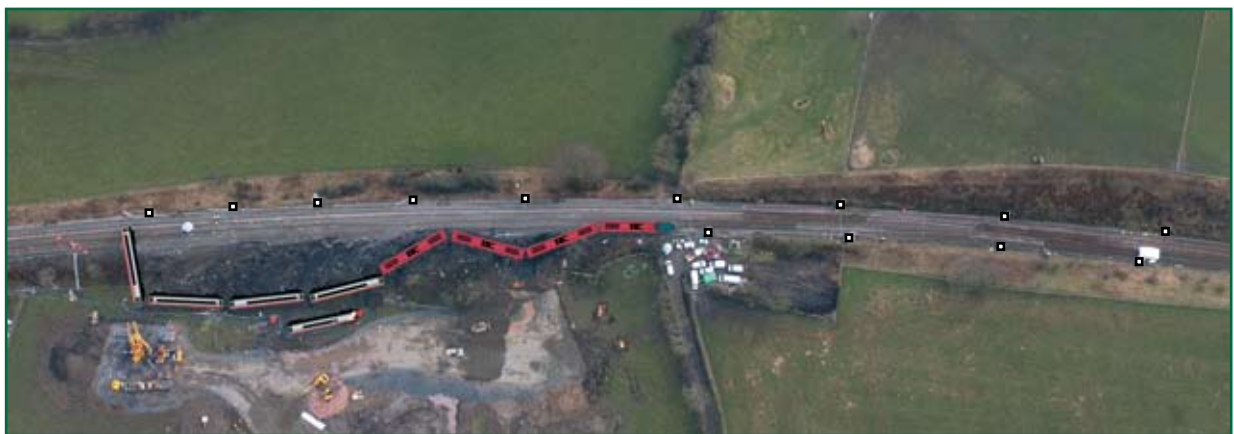
Figure 36: Final location of the vehicles from train 1S83 after the derailment

547 Vehicles six to nine remained coupled and followed the preceding vehicles, coming to rest variously orientated on the embankment slope and in the down cess, with the cab of vehicle nine just past the toes of 3A points. The leading bogie of vehicle six was found on top of the concrete block first struck by vehicle five and, which formed the foundation for mast M2. Figure 36 shows the final location of the vehicles. The time from the moment of the derailment until all the vehicles came to rest was approximately 13 seconds.

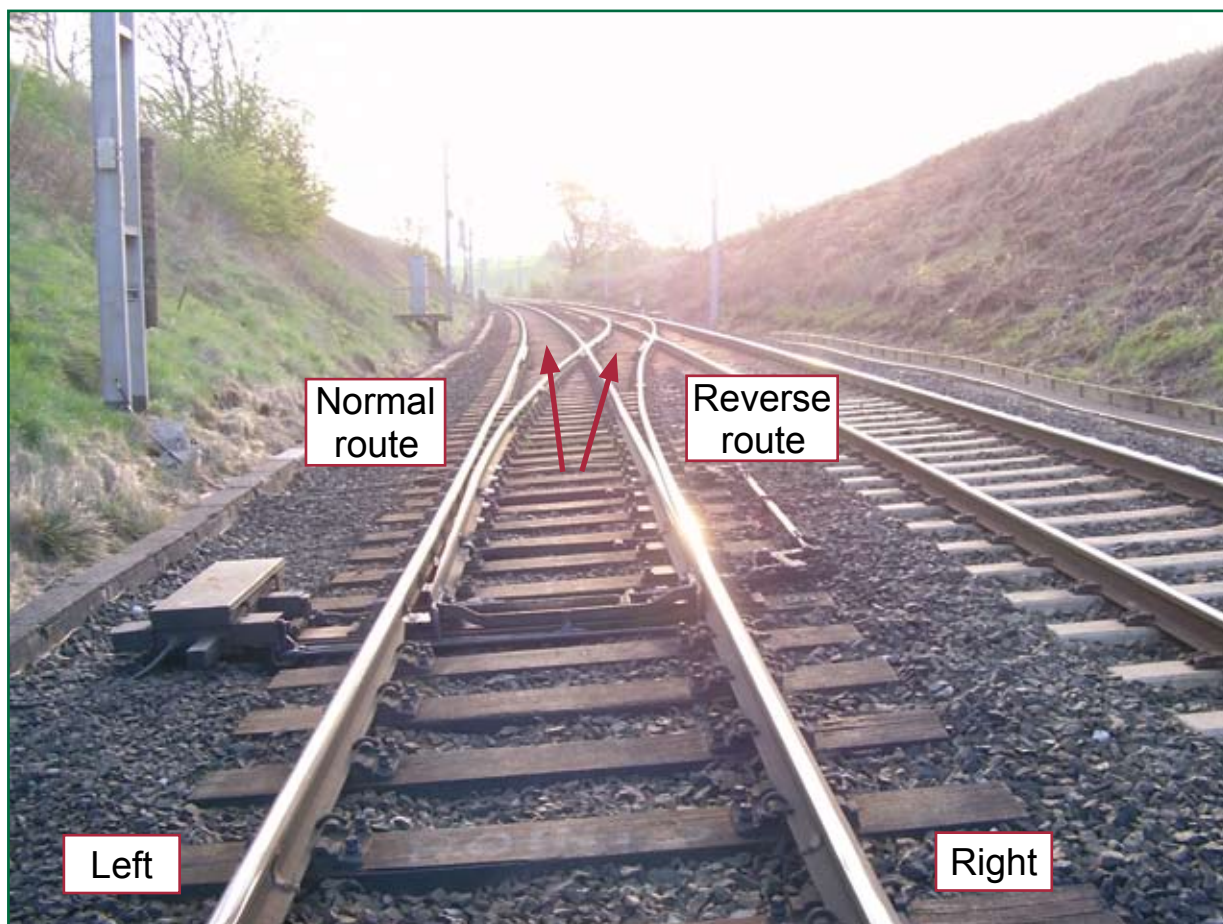
Figure 42: Lambrigg 2B points in May 2006 (courtesy of Network Rail)

- 2 In the UK the two switch rails are maintained a set distance apart and are made to move together by a series of stretcher bars. The bar at the toes, ie the movable end of the points, is known as the lock stretcher bar, and along with detector rods (attached to the switch rails via switch rail extension pieces), indicate to the signalling system that the switches are correctly positioned. The other stretcher bars are known as permanent way stretcher bars.
- 3 Facing points are used where two routes diverge in the direction of travel, and trailing points where two routes converge. Lambrigg 2B points were facing points (Figure 42).

- 4 The 'normal' status for points is usually when they are set for their main route, and the 'reverse' status when set for the diversionary route. The operation of 2B points was that with the points set to 'normal', the left-hand switch rail was open and the right-hand switch rail was close to its adjacent stock rail. This is the position shown in Figures 40 and 41.

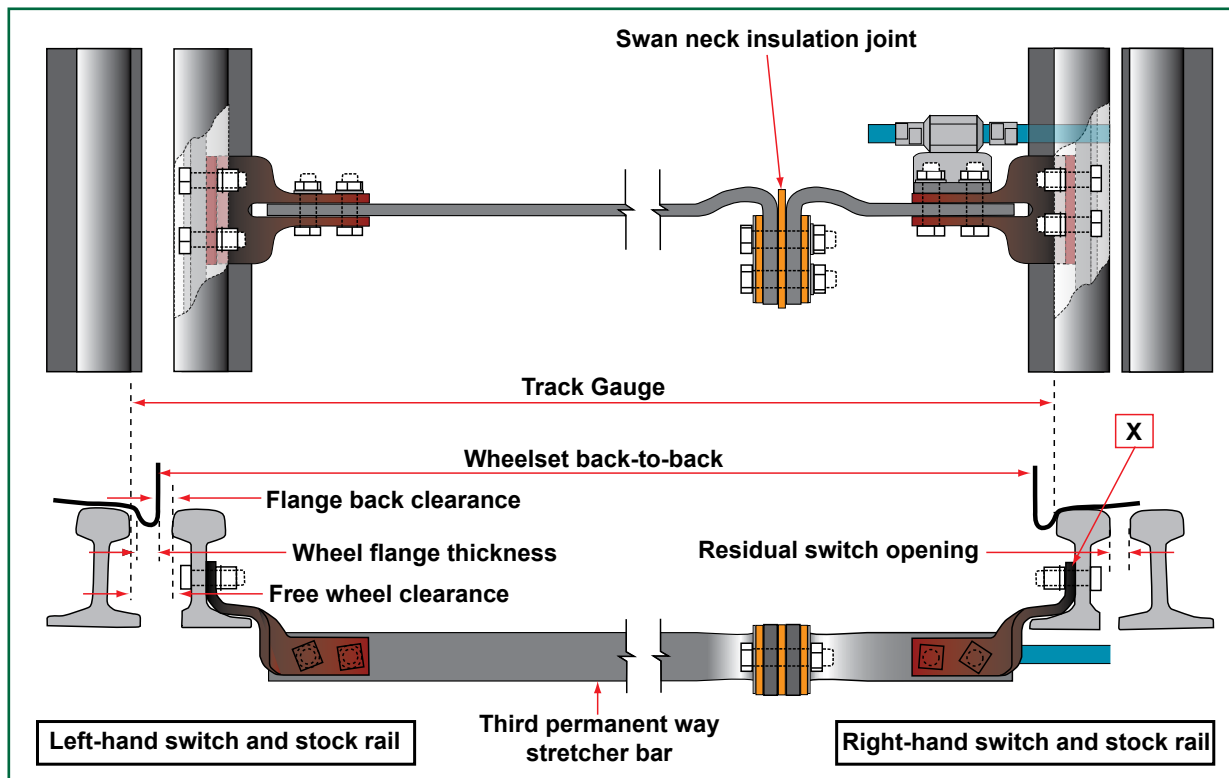
Figure 43: Schematic diagram of points indicating key terms

- 6 To allow for the operation of track circuits, non-adjustable stretcher bars are divided into two parts, connected by a bolted insulated joint, commonly known as a swan neck (Figure 43). The two sections of the stretcher bar are of unequal length.

- 16 It can be seen from Figure 43 that with a set length of stretcher bar the degree of static free wheel clearance on the left-hand switch rail is affected by the amount of residual switch opening between the right-hand rails. However, passing trains are likely to close the residual switch opening, thus increasing the free wheel clearance as the left-hand switch rail is pulled further open by the stretcher bar.

- 17 If the joint between the stretcher-bar bracket and the right-hand switch rail fails (marked as X on Figure 43), the left-hand switch rail will tend, due to its natural flexure, to relax towards its stock rail and hence reduce the free wheel clearance. The position the rail now adopts is controlled solely by its connection to the supplementary drive, and by the remaining stretcher bars. When trains pass with the stretcher bar in this condition, the closing of the residual switch opening will no longer increase the free wheel clearance, increasing the likelihood of flange-back contact. The degree of flange-back contact will be related to the position of the four-foot nuts of the escapement joint (Figure 43) since this determines the amount of residual switch opening prior to any joint failure.

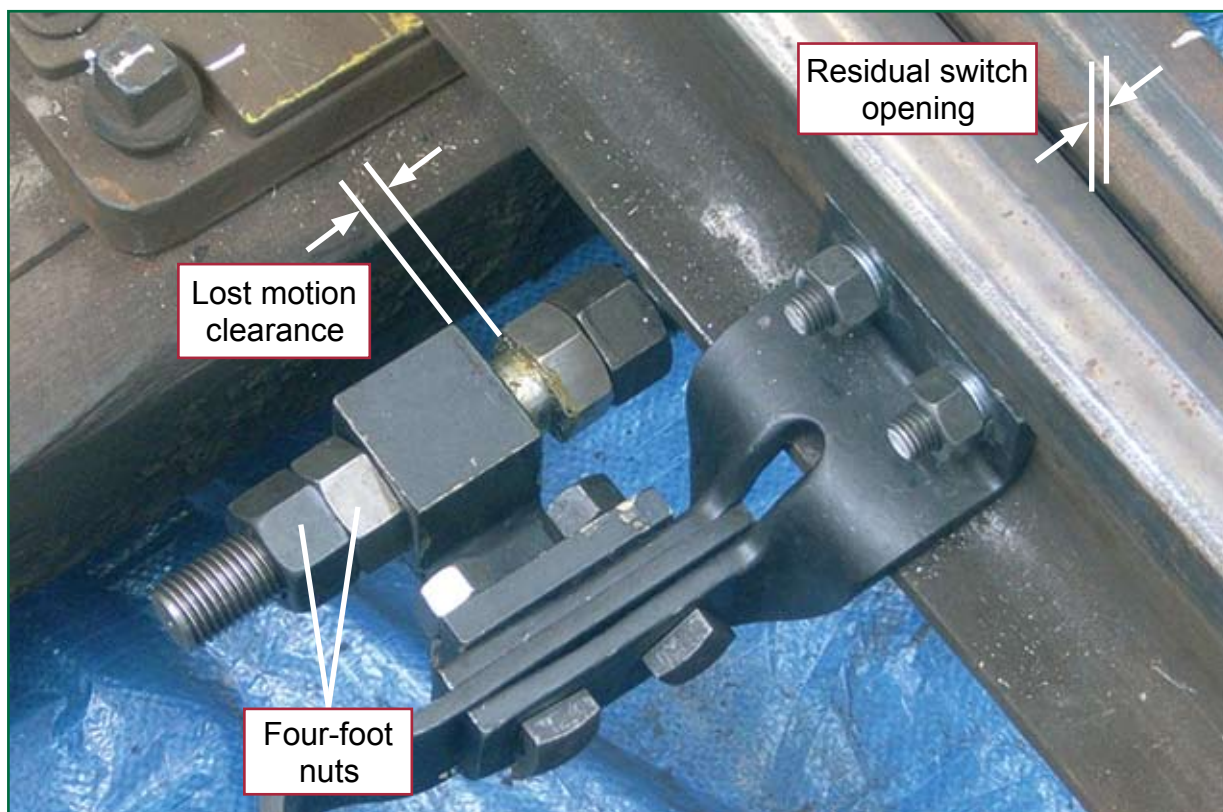
Figure 44: Escapement joint on a reconstructed stretcher bar

- 14 There is an escapement joint at the point of connection between the supplementary drive and the third permanent way stretcher bar (Figure 44). Clearances within this joint, known as lost motion, isolate the supplementary drive and the toes of the switches from any switch rail movements and associated forces induced by trains that could cause damage.

- 15 The adjustment of the clearance at the escapement joint allows installers and maintainers to alter the position of the closed switch rail relative to its adjacent stock rail. Any gap present between the two rails at this location is known as the residual switch opening (Figures 43 and 44). Network Rail found from experience that it was beneficial to have a small gap present between the rails at this location to prevent the points from seizing due to changes in temperature affecting the supplementary drive. Standard NR/GN/SIG/11772, applicable at the time of the accident, stated that the residual switch opening should be 1.5 mm; however, no tolerance or maximum figure was specified.

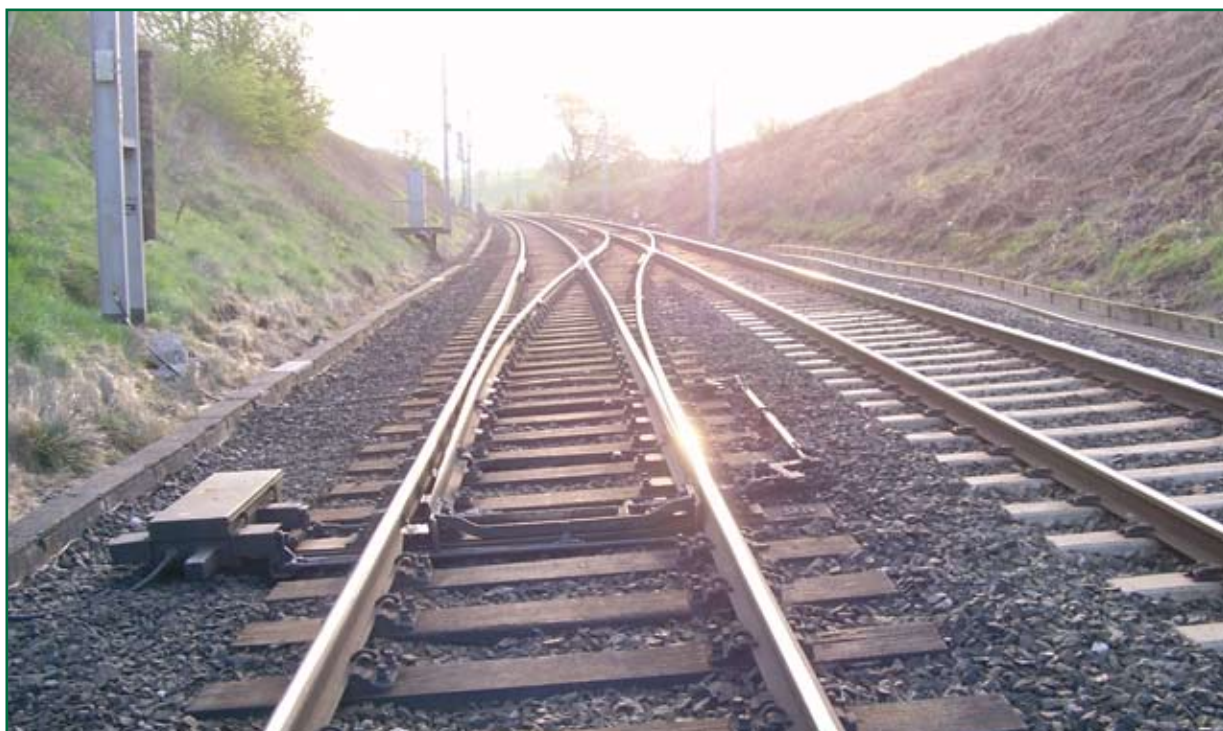
Figure 46: Lambrigg 2B points, May 2006 (courtesy of Network Rail)

- 3 It is possible to make scaled measurements from the Omnicom video and these can be calibrated against a known dimension in the photo.
- 4 During 2004, the Omnisurveyor3D route photography train ran past Lambrigg on the down line. The RAIB's study of the video taken on that run showed that all three stretcher bars in 2B points were in place, and that there was a residual switch opening in the vicinity of the third stretcher bar (on the closed side) that was between 6 and 8 mm.

- 5 A still photograph taken by a Network Rail engineer in May 2006, during a routine inspection of the track, gives evidence that an excessive gap was still in existence at that time (Figure 46).

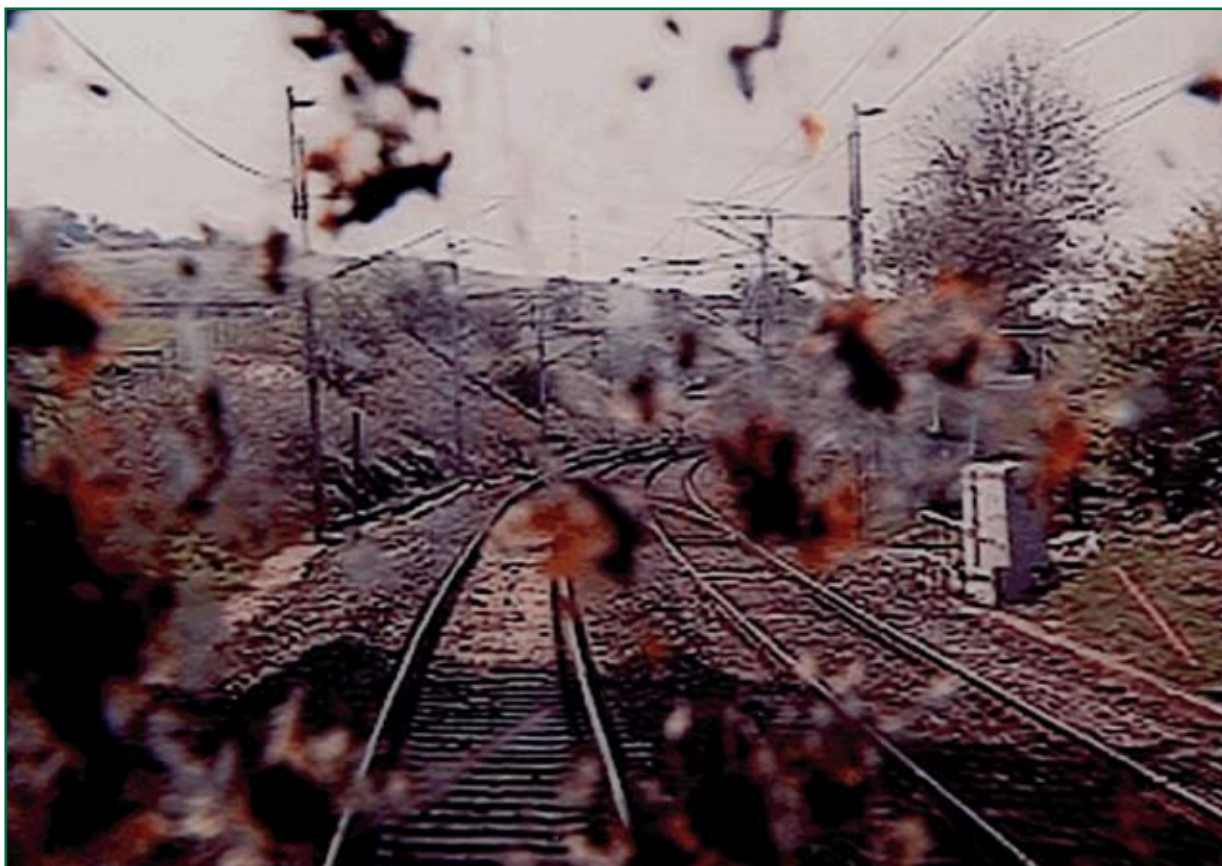
- 12 The NMT is fitted with forward and rearward facing video systems. These are provided for Network Rail engineers to relate geometrical records to physical locations, and are neither used nor intended for condition analysis. In May 2006 the NMT front-facing video was taken in good lighting conditions on a run on the up line. It shows points 2B to have all three permanent way stretcher bars present. The approach to the former crossing at Lambrigg, where the site access was located, can be seen clearly and a length of rail can be seen behind the location cabinets on the down side (Figure 47).

*Figure 47: Approach to Lambrigg viewed from the up line in May 2006. Scrap rail behind location cabinet is visible*

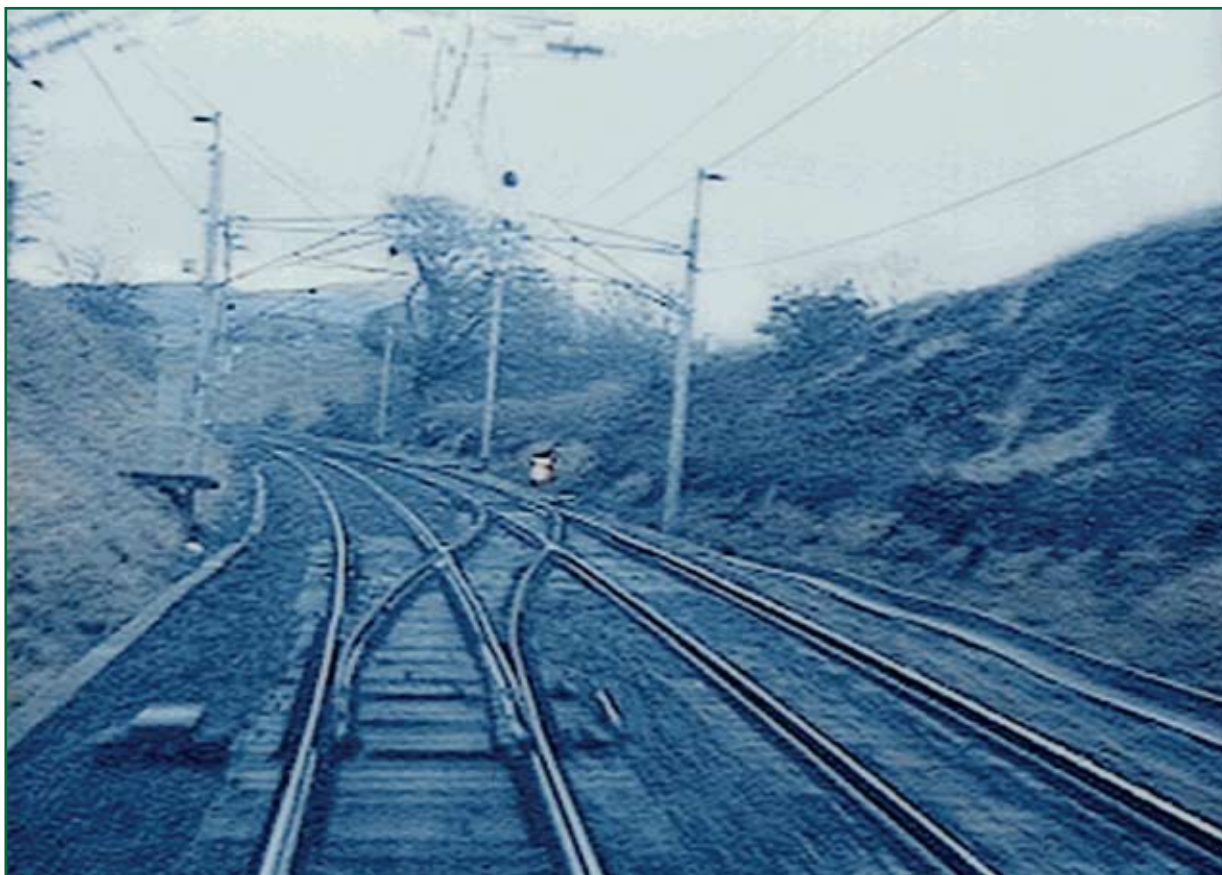
*Figure 48: Points 2B viewed from the front of the NMT on 10 January 2007*

- 14 On 10 January 2007, the NMT ran in slightly better lighting conditions than the previous week and the front-facing camera was working. Points 2B appear to have all three permanent way stretchers present (Figure 48). The NMT is fitted with a laser-based six-foot scanning system. This measures the distance from the scanner to any object in its path beneath the train. The data from this system was analysed by the RAIB to derive the relative positions of the switch and stock rail at 2B points. The six-foot scanner data shows the minimum free wheel clearance (Appendix D, paragraph 12) to be of the order of 60 mm.
